Manhole Inspection Summary

Manhole # S33CC2022MH

Insp Date: **12/19/06 3:35 PM**

Location Address: **5507 SPRINGLAKE WAY**

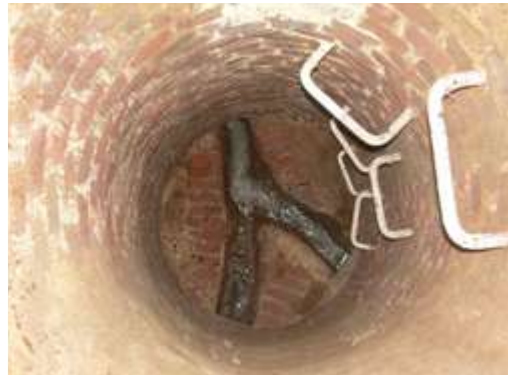
Top View

Bench debris.

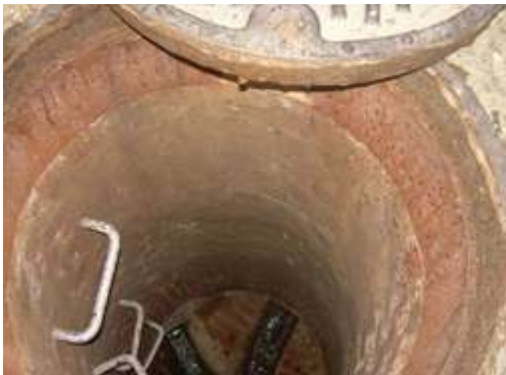
Defect

Adjustment deterioration and infiltration.
Corbel and Barrel infiltration - other side.

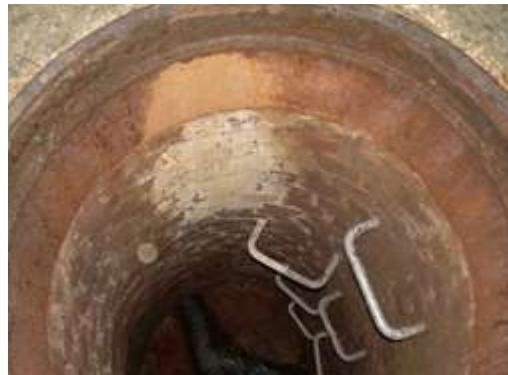
Defect

Adjustment deterioration and infiltration.
Corbel and Barrel infiltration.

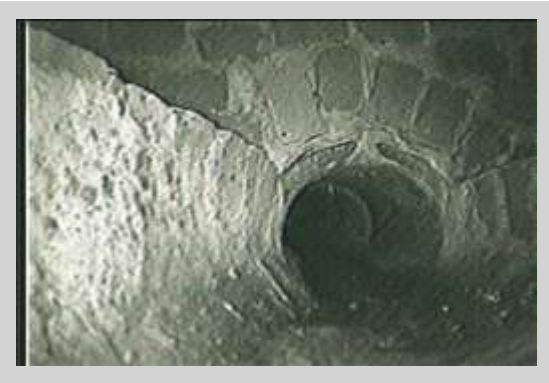
8 in. Circular Gravity Sewer Pipe Out @ 12 O'Clock

Deposits: ☐ None ☒ **Mud** ☐ **Gravy** ☒ **Debris** ☐ **Grease**

Silt Depth: **0.5** (in.) Deposits Extent: **Light**

Infiltration: **Evidence** Pipe Seal Cond: **Unknown**

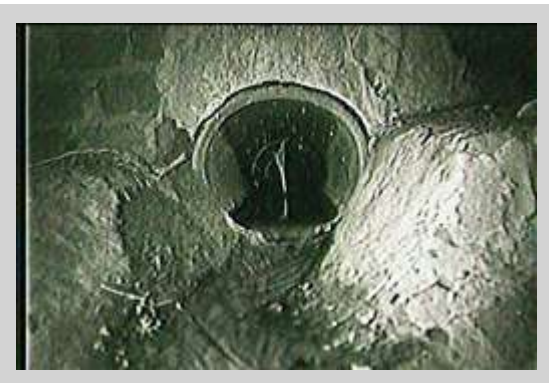
8 in. Circular Gravity Sewer Pipe In @ 4 O'Clock

Channel root intrusion.

Infiltration: **Evidence** Pipe Seal Cond: **Unknown**

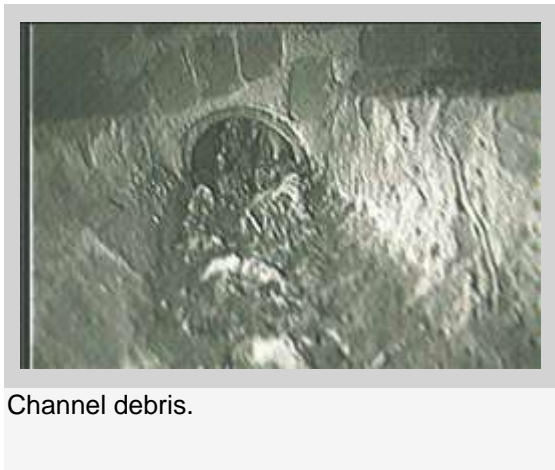
6 in. Circular Gravity Sewer
Pipe In @ 7 O'Clock

Channel debris.

Deposits: ☐ None ☒ **Mud** ☒ **Sludge** ☒ **Debris** ☒ **Grease**

Silt Depth: **3** (in.) Deposits Extent: **Medium**

Infiltration: **Evidence** Pipe Seal Cond: **Unknown**
